TIRE PRINTS ON THE RIM

By Mark W. Arndt

ACCIDENT RECONSTRUCTION JOURNAL

July/August 2013

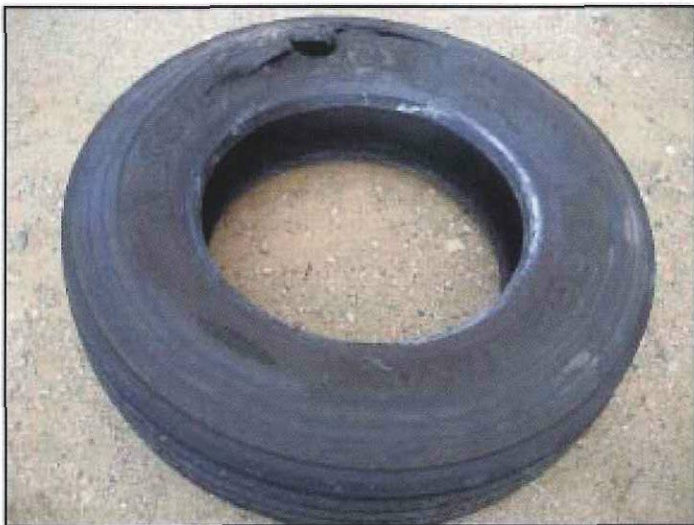
Figure 1

Despite, or perhaps because of, numerous well paid experts and layers of circumstantial evidence, a key question in a crash that resulted in the forced removal of a heavy truck's front tire from its rim became - which side of the tire was mounted inboard? In the present context, the legal wrangling that presented this question is not important, but instead the solution to the puzzle. The tire was found disconnected from the rim after a serious injury head-on crash in which the investigating officer, after conferring with the local tire shop, reported that the tire lost air before impact. One of the officer's photographs documenting the tire at the scene is figure 1.

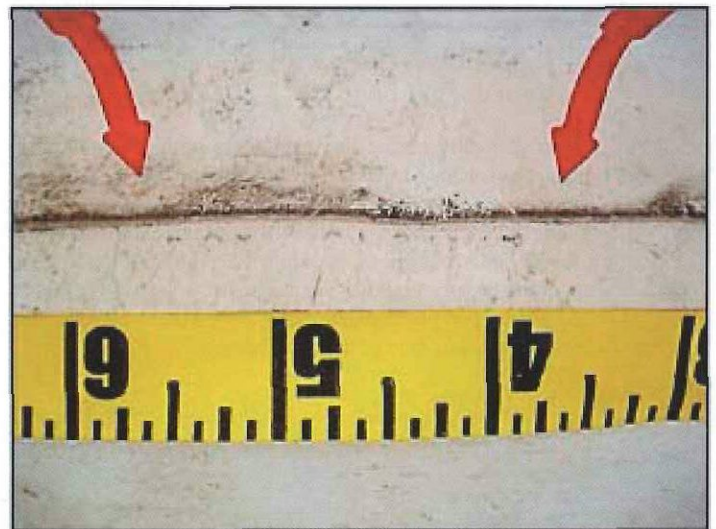
discernible but undecipherable markings. The markings, including regular tic marks, were within a band of darkening that extended the circumference of the rim. Figure 2 shows the band of darkening and Figure 3 is an example of a pattern of marking. The patterns of marking launched a search for their possible source on the tire.

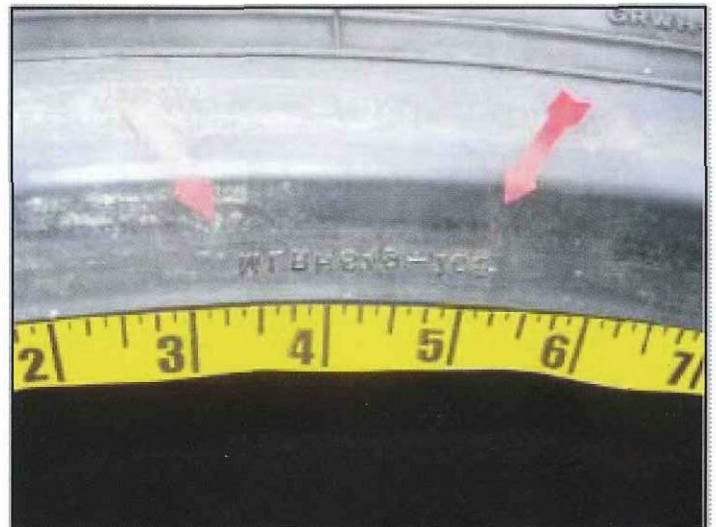
The tire's beads, in fact, revealed numerous raised features including several series of numbers. Raised tic mark features appeared to lie on a regular interval but were similar on both inboard and outboard beads of the tire. The numbers were unique and only present on one bead. The question became can the pattern of numbers be demonstrated to be the same as the marking on the rim flange? Figure 4 shows raised features on the tire bead.

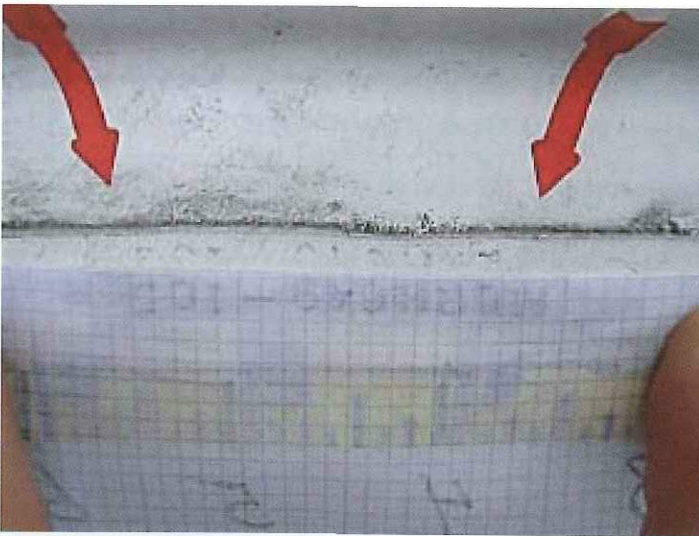
result was a perfect match of the tire's numbers with the previously undecipherable pattern on the rim. Carefully referencing the rim to the tire, the process was repeated for each tire bead marking producing consistent results and agreement. Figure 5 shows alignment and agreement of the tire bead pattern to the rim's pattern of marking. Careful examination and documentation of the tire printing on its rim, like finger printing, allowed for a conclusion based upon physical evidence about which side of the tire was present on the outboard face of the rim flange.

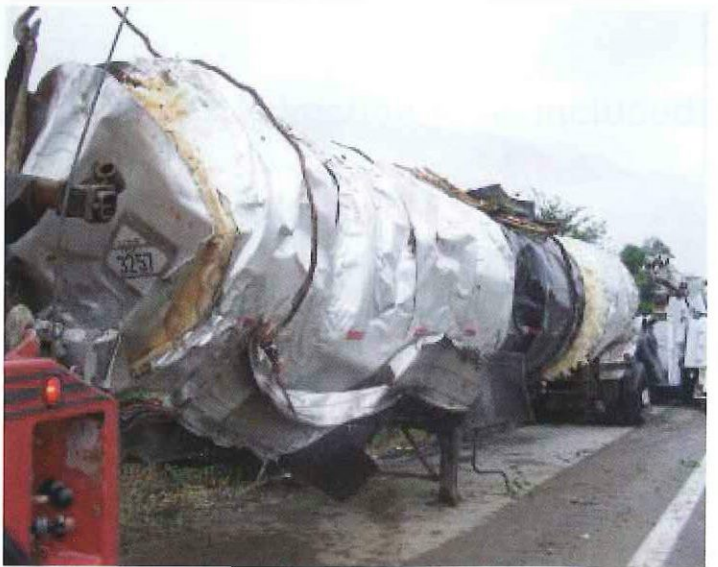
As the driver approached the exit, he crossed the fog line and sideswiped the driver's side of an SUV parked in the emergency lane with the semi's right steer tire. After striking the SUV with the steer tire, the semi became uncontrollable and went through the guardrail on the north side of the west bound lane emergency lane. Upon going through the guardrail, the unit proceeded downward into a ravine where tanker dislocated from the semi. Both the semi and tanker struck numerous trees and received considerable damage. According to the police report, the driver had utilized the restraint system, but was still ejected from the semi.

The *ARJ* cover photograph shows the semi-tractor after it had been pulled out of the ravine and back up onto the shoulder. The photograph below shows the tank trailer involved in this incident after it had been pulled back up onto the shoulder.
