## **Analysis of Causes of an Unintended Rollover During a Tread Separation Event Test**

**Abstract** - A high speed multiple rollover crash occurred during a test program designed to evaluate the disturbances to a vehicle's straight ahead steady state path caused by a rear tire tread separation event. The tread separation that induced the crash was a partial tread separation event. The test run resulting in the rollover is documented by on-board test instrumentation and standard post-test crash investigation methods. Testing reported in previous papers documents a distribution of forces that cause an external disturbance to vehicles during tread separation events. These papers also document changes to vehicle steering characteristics following tread separation events. By themselves reported tread separation induced forces are insufficient to cause the initial vehicle motion in the rollover crash. Testing presented in this paper documents a change to vehicle handling stability due to tread separation induced rear wheel hop. Rear wheel hop and a special hop condition called tramp resulted in oversteer causing the vehicle to make an unintentional rapid turn. Characteristics of tread

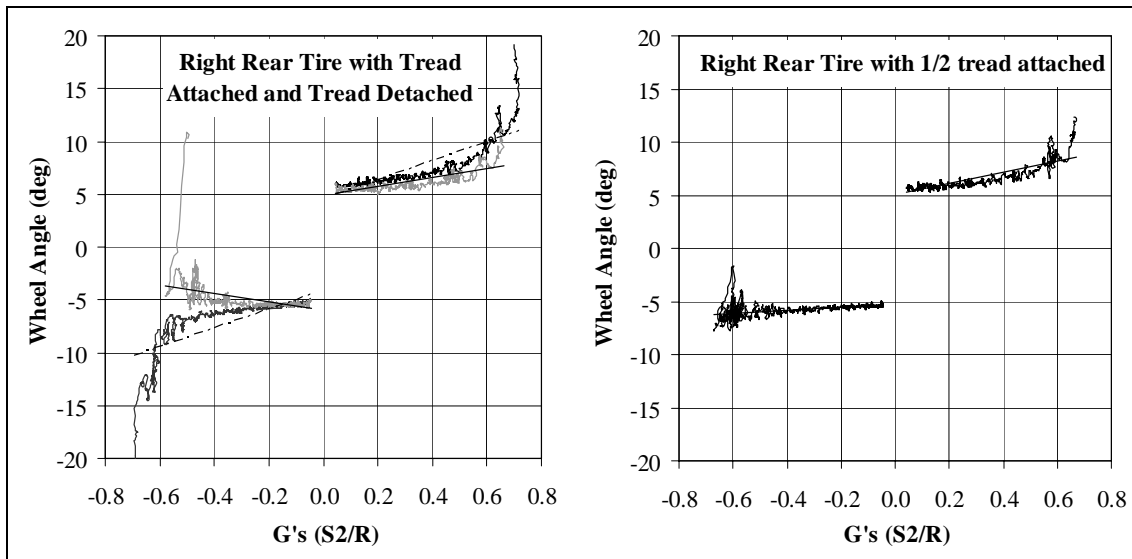
The results of circle turn testing on the Ford Explorer at curb weight plus driver and instrumentation is shown in Figure 1. This chart compares the vehicle response when equipped with four tires with tread attached versus the condition when the right rear tire has all of the tread and outer steel belt removed. Figure 1 also shows the response of the same vehicle with half the circumference of the right rear tire’s tread and outer steel belt removed. All of the tires were inflated to the vehicle manufacture’s recommended pressure. Figure 2 summarizes the calculated steer gradient from the circle turn test results. The steer gradient was calculated over the range of 0.05 G to 0.25 G.

Figure 1. Steer characterizations, dark line in left graph is vehicle with unmodified tires

The circle turn testing is conducted on a circle of 100 ft (30.5 meter) radius. The peak speed attained during the circle turn testing was well below highway speed and the natural frequency of the rear suspension. The low speed in circle turn testing isolates the vehicle response in the half tread test condition to the response due to missing tread. The overall result supports a rule-of-thumb that there is a linear relationship between the percent missing tread and the percent steer gradient reduction due to the missing tread on an inflated tire. Removing half the circumference of a tire's tread and outer steel belt changes a vehicles steering, but for the lightly loaded Explorer tested at low speed the change does not cause an oversteer condition in the 0.05 G to 0.25 G linear range. Significant effects on vehicle handling, particularly in the linear range, due to the vibration produced during the half tread tests were likely not measured in low speed circle turn testing.

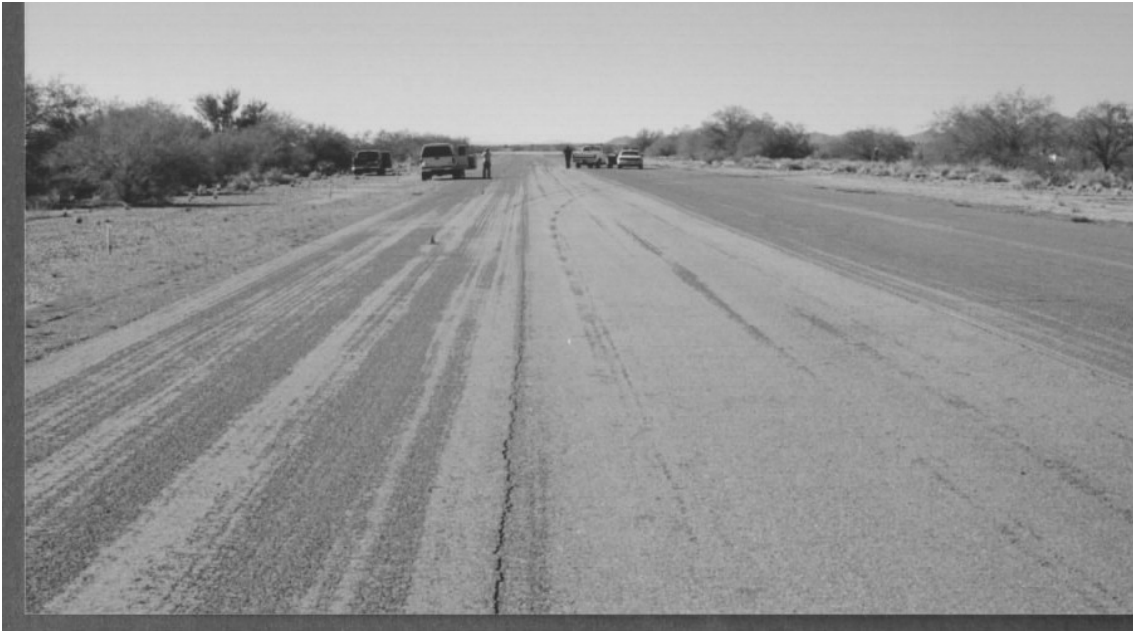
Photographs taken at the test crash site of the tire marks document skipping that is characteristic of wheel hop and axle tramp in the Ford Explorer (Appendix A, photographs 1-3). Hop or tramp induced roadway marking are probably not always observed or documented in real world crashes. Photographs 3 and 4 (Appendix A) show the left rear tire marks as initially skipping and then translating to a wavy tire mark. The same skipping tire marks are documented in measurements and are shown in Appendix A, diagram 3. The tire marks prior to significant vehicle turning are characteristic of wheel hop and axle tramp. Body roll of the sprung mass and weight transfer occurs as the vehicle begins to respond to turning motion. The effect of body roll and weight transfer is a

Photograph 1. Start of hopping right rear tire marks

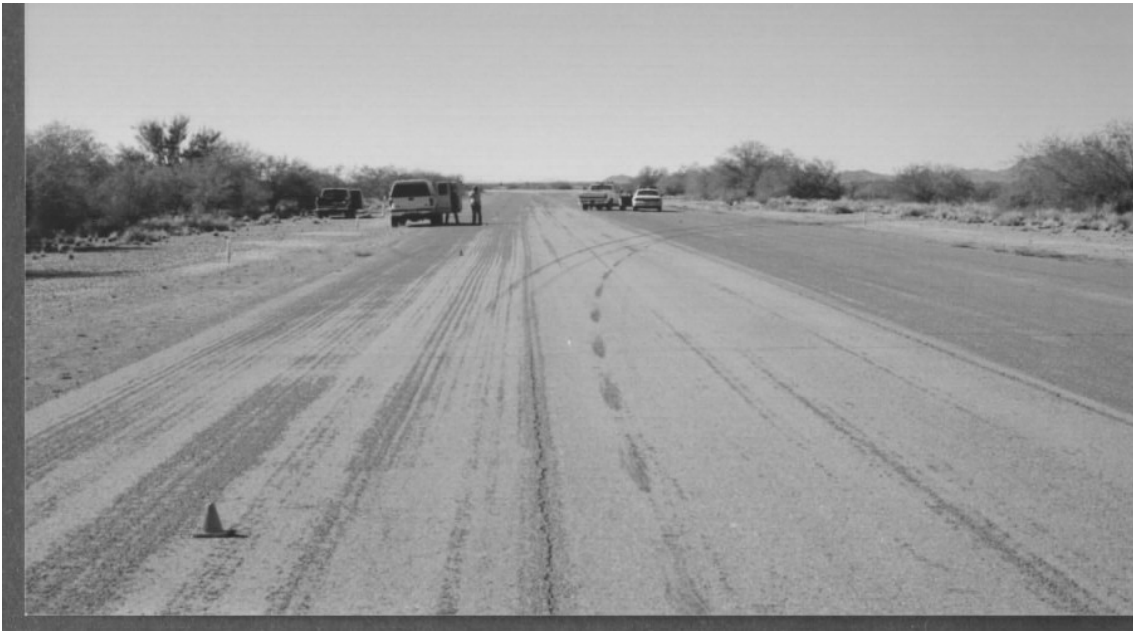
Photograph 2. Hopping rear tire marks

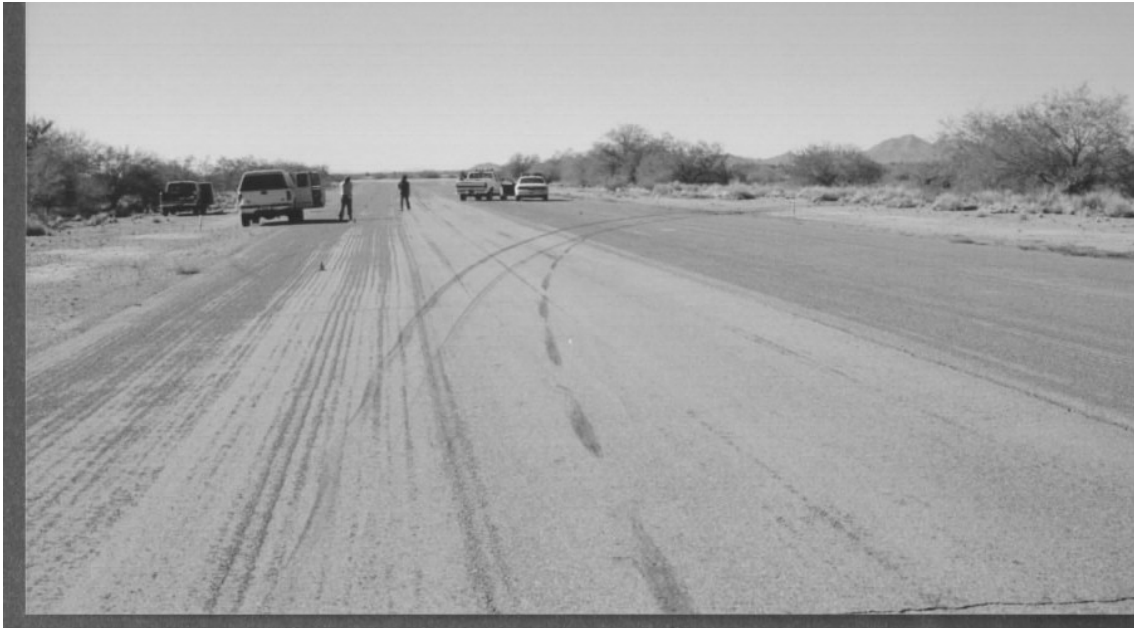
Photograph 3. Hopping rear tire marks

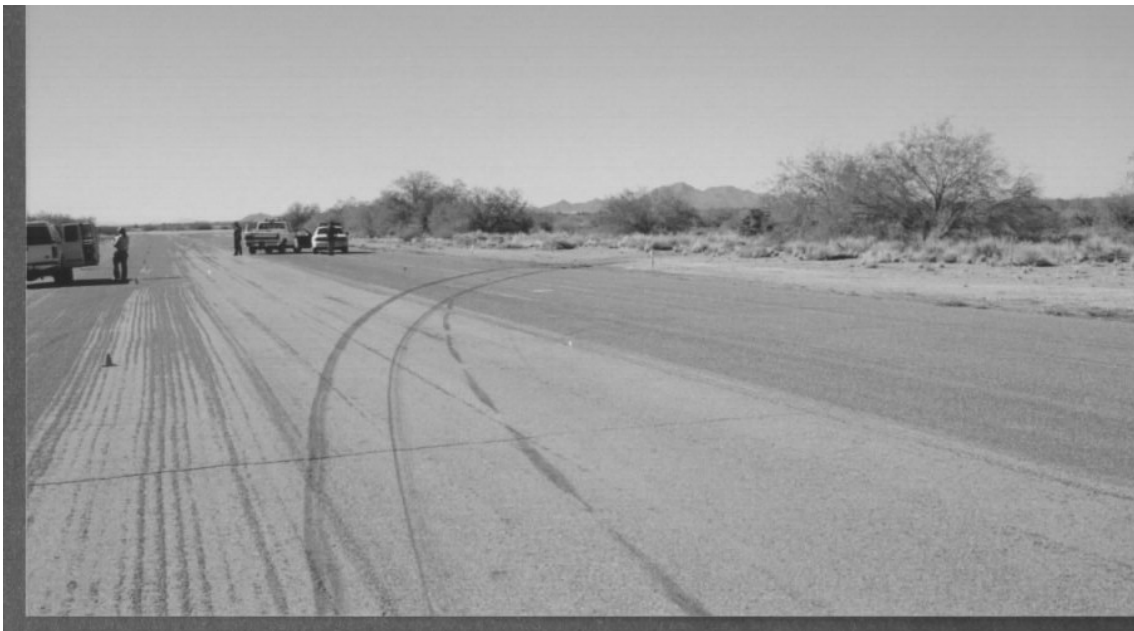
reduction in axle tramp due to asymmetric loading of the vehicle suspension. Diminished axle tramping is visible in the photographs as the vehicle progresses in its turning motion. In Appendix A, photograph 5 no tramp motion is visible in the vehicle tire marks because of diminished vehicle speed, slip angle, reduced tire rpm and asymmetric loading of the vehicle suspension.

Photograph 4. Hopping/wavy rear tire marks

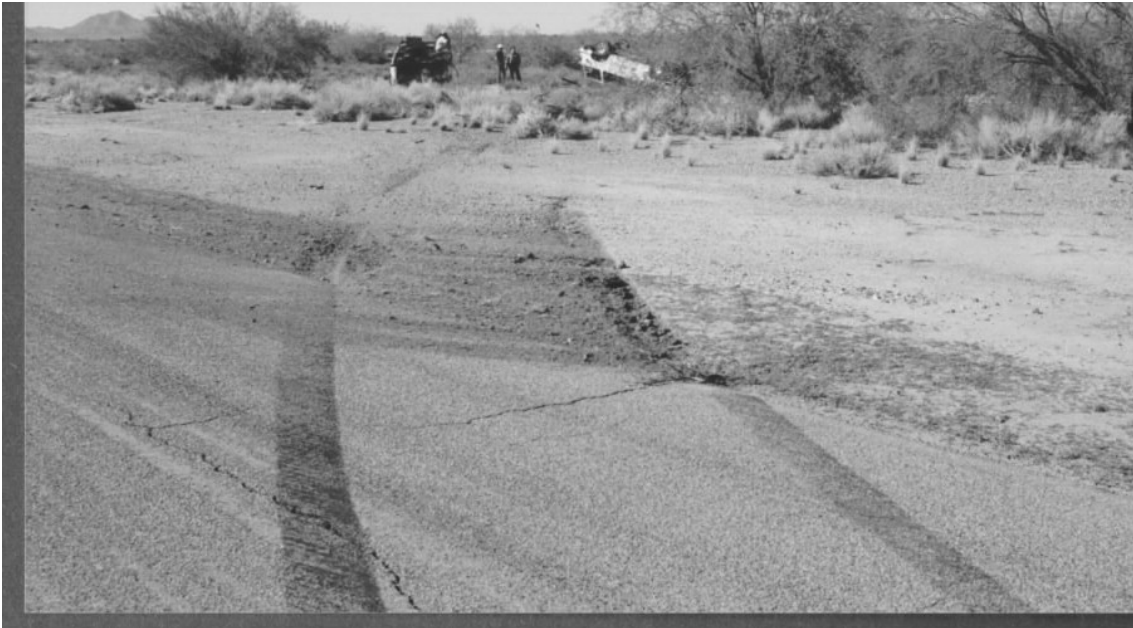
Photograph 5. Left tire marks, hopping not present

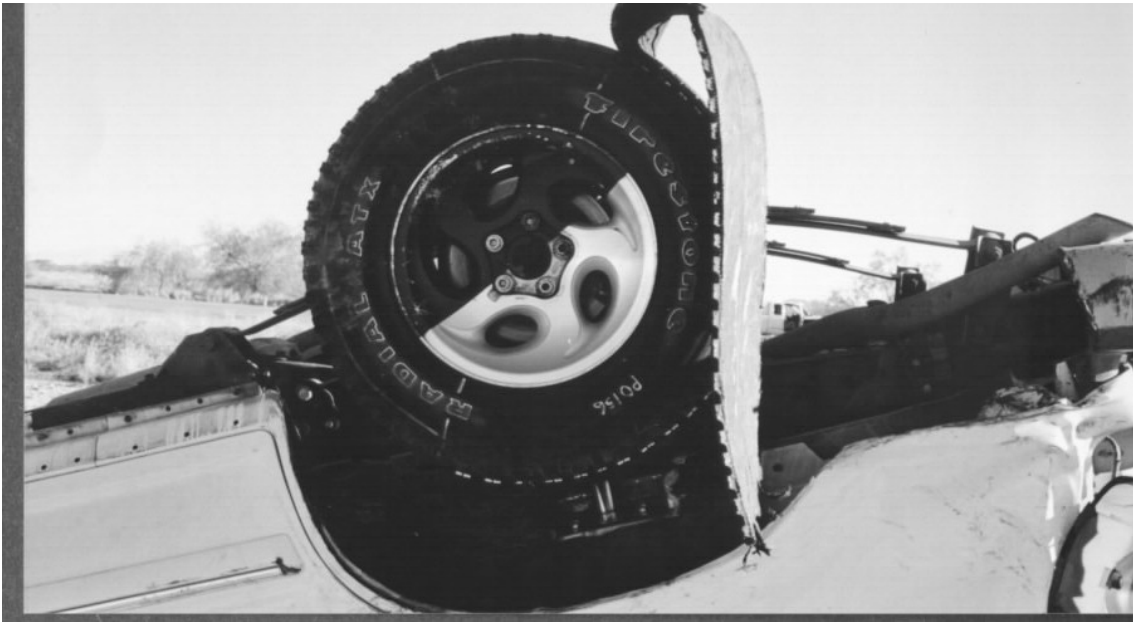
Photograph 6. Tire at point of rest
