MESA SCHOOL BUS TESTINGIntroduction

On April 2, 3, 6 and 7, 1987, inspection and testing of nineteen Mesa Unified School District buses were conducted. The testing included sixteen Blue Bird buses and three Thomas buses. Testing and inspection were general in nature and designed to evaluate the overall operating condition and adequacy of the vehicles' air brake systems.

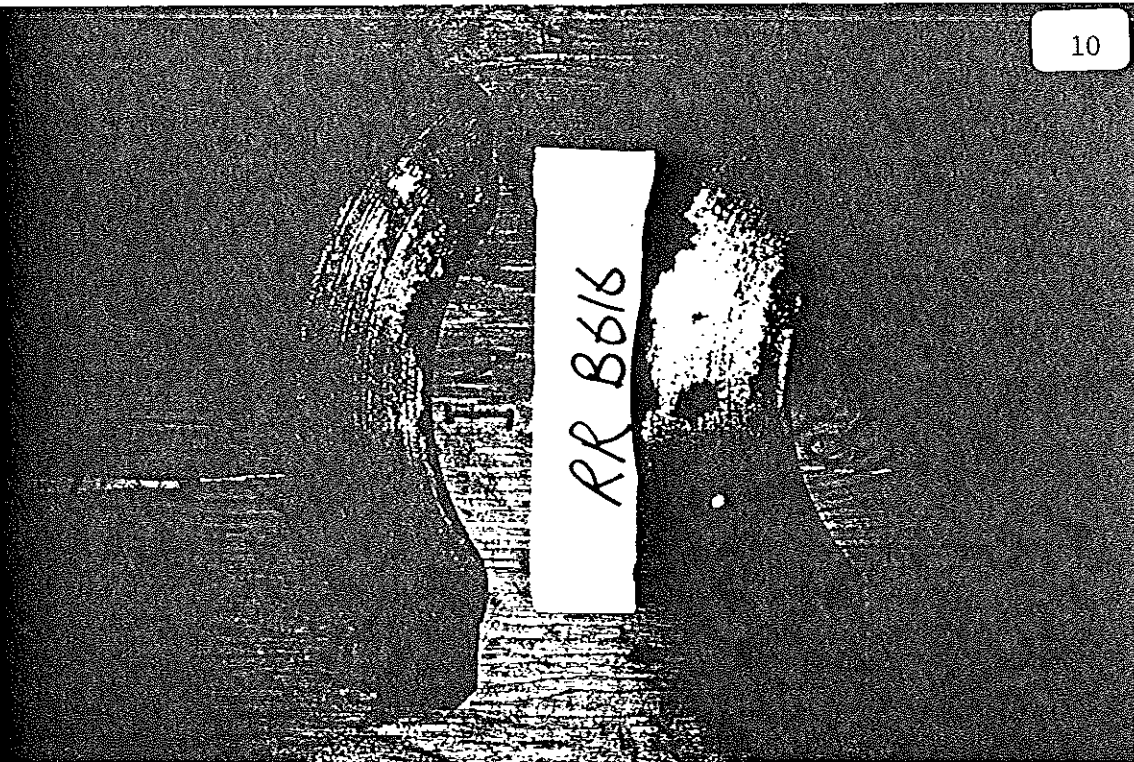
RR B616

The inspection procedure revealed isolated cases of severe brake pad wear on several of the Blue Bird buses. Two of the buses, B-614 and B-616, had sustained excessive pad wear causing metal to metal rubbing of the rotor and pad backing plate. The mileage on B-614 and B-616 was 10,934.4 miles and 16,626.7 miles, respectively. Two other buses, B-507 and B-613, has sufficient brake pad wear to warrant pad replacement. The metal to metal condition of the brakes is a potentially serious problem because of the rapid wear rate and decreased braking effectiveness when hot. Photographs of the available brake pads and rotors are included in Attachment 3.

The brake wear observed on buses B-614 and B-616 was excessive and should not occur. A reasonable explanation for the cause of this excessive wear on relatively low mileage brakes should be solicited in writing from the manufacture.

Because there appears to be some problem associated with brake pad wear, inspection of all brake pads should be conducted every 3,000 miles. This inspection schedule could be extended if the incidences of extreme brake pad wear decrease. If the incidences decrease, then inspection of the pads should be conducted at the manufacturer's recommended time intervals.
